[Docket No. 2003-SW-06-AD; Amendment 39-13064; AD 2003-04-15]

Airworthiness Directives; Sikorsky Aircraft Corporation Model S-76A, B, and C Helicopters

2003-04-15 Sikorsky Aircraft Corporation: Amendment 39-13064. Docket No. 2003-SW-06-AD.

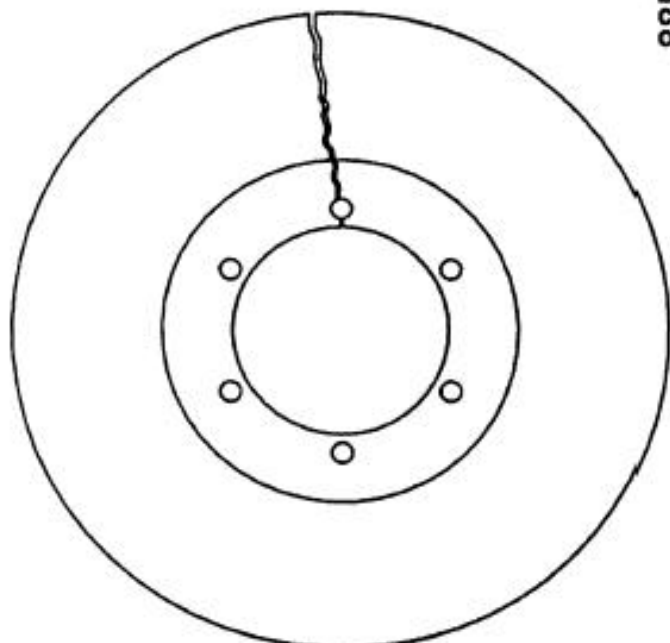
VIEW A

**CRACK THROUGH WALL
REPLACE DISC PRIOR TO NEXT FLIGHT**

(1) If you find a crack through the entire RBD thickness as shown in Figure 1, View A, replace the RBD with an airworthy RBD, other than P/N 76363-09103-104, before further flight.

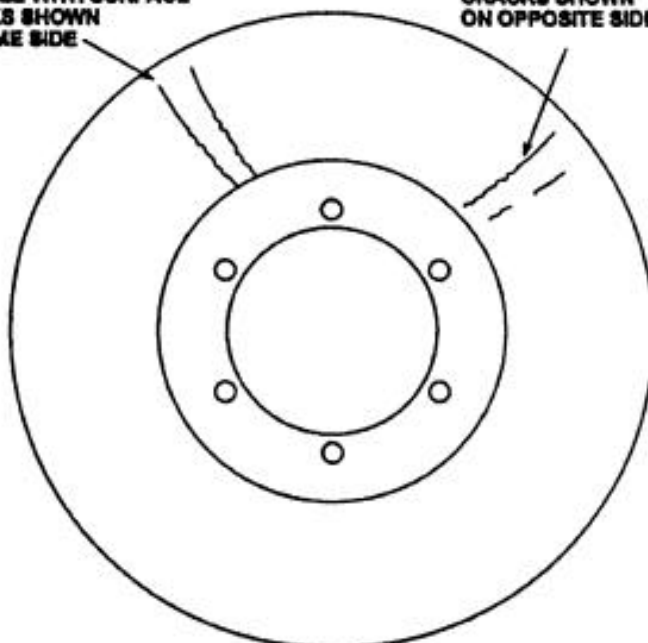
VIEW B

**MULTIPLE CRACKS BETWEEN 2 ADJACENT BOLT HOLES
REPLACE DISC PRIOR TO NEXT FLIGHT**

**EXAMPLE WITH SURFACE
CRACKS SHOWN
ON SAME SIDE**

**EXAMPLE WITH SURFACE
CRACKS SHOWN
ON OPPOSITE SIDE**

(2) If you find two or more surface cracks between adjacent boltholes as shown in Figure 1, View B, replace the RBD with an airworthy RBD, other than P/N 76363-09103-104, before further flight.

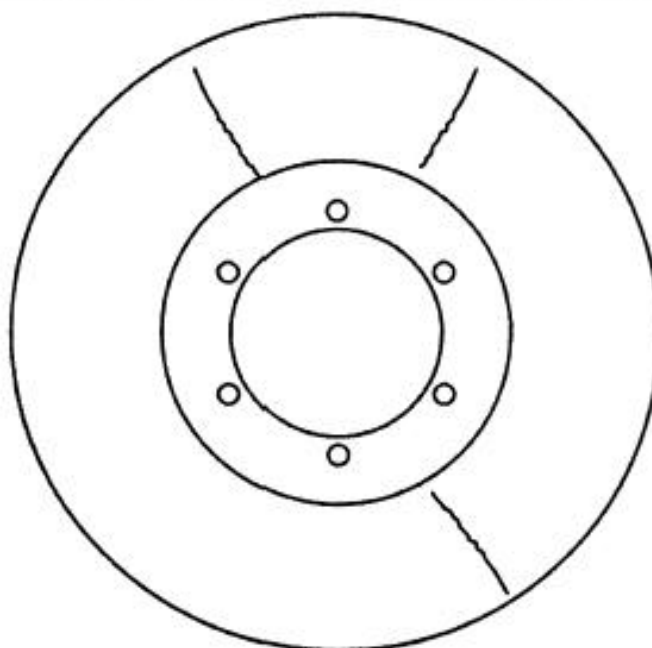
VIEW C

**Multiple Surface Cracks Separated by Boltholes
Replace Disc or Deactivate Brake Prior to Next Flight**

(3) If you find a surface crack or surface cracks separated by the boltholes as shown in Figure 1, View C, replace the RBD with an airworthy RBD, other than P/N 76363-09103-104, or deactivate the RBD before further flight.
